# Manhole Inspection Summary

Manhole # S37Q\_\_046MH

**Inspection** ☐ Is Incomplete Rating: **3) Fair**

**Location** Address: **1100 Covington St**

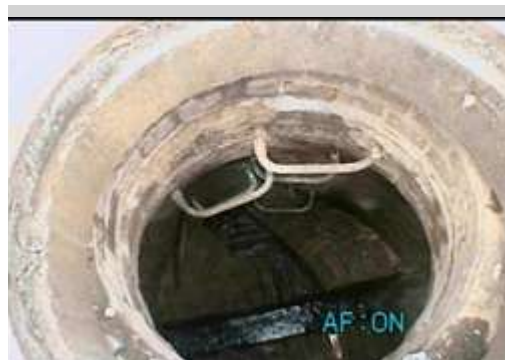
Defect 4

bench debris

corroded steps

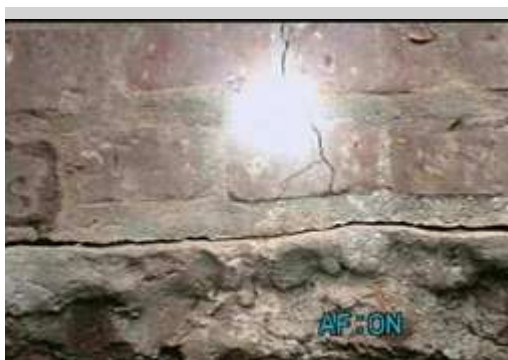
Defect 3

Condition: ☐ Sound ☒ **Cracked** ☐ Root Intrusion ☐ Loose Brick ☐ Deteriorated

cracked corbel

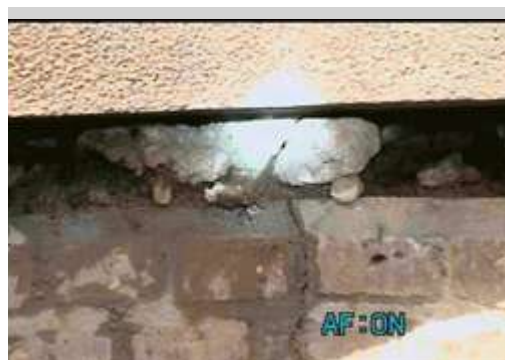
Defect 2

Condition: ☐ Sound ☒ **Cracked** ☐ Root Intrusion ☒ **Loose Brick** ☒ **Deteriorated**

cracked chimney deteriorated, loose bricks frame adj

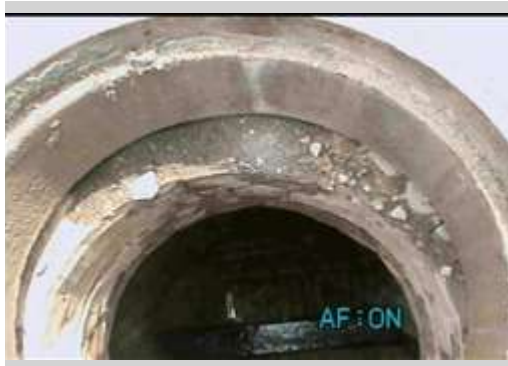
### Defect 1

**Frame** Offset: **4** (in.) Condition: ☒ Sound ☐ Cracked ☐ Leaks

frame offset

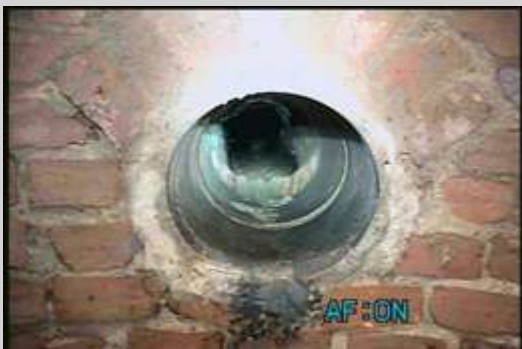
6 O'Clock Inflow

Deposits: ☐ None ☐ Mud ☐ Sludge ☒ Debris ☐ Grease

Silt Depth: 2 (in.) Deposits Extent: Light

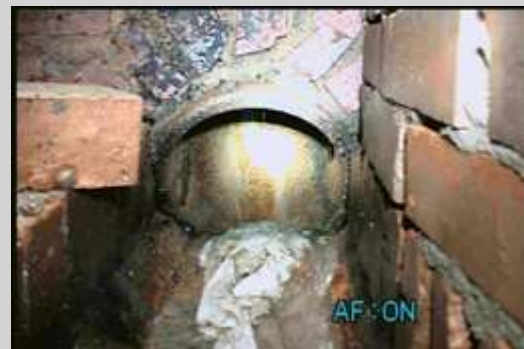
Drop In @ 6 OClock

Drop: Outside Direct

Drop Condition: Open
